Town of Lincoln

Building Needs Assessment

July 24, 2006

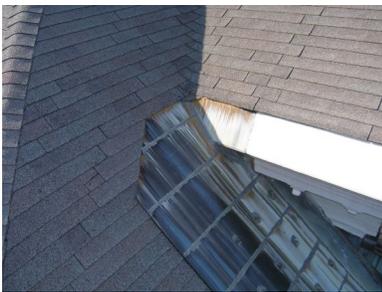
B-1 The building originally had a slate roof, which was replaced approximately 25 years ago with a black asphalt shingle roof. The building's copper gutters and flashings were not replaced at that time. The asphalt shingles are still serviceable but are showing their age with shrinkage between shingles, and they should be replaced in about five years. At that time, all of the building's flashings and gutters should be replaced. The small basement stair roof at the rear of Bemis Hall is quite weathered and brittle. We have priced a new asphalt shingle roof in our prioritized cost estimate. Although, the first cost of slate roof is significantly more than asphalt, the life cycle cost of slate is usually less if slate is considered. We strongly recommend that only natural slate be considered for the slate option, since faux slate has a very mixed performance record.

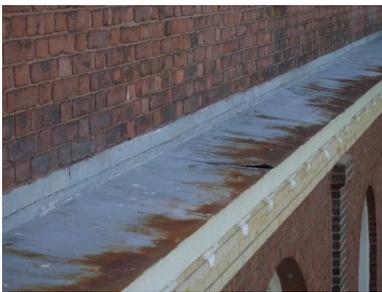
B-2 The horizontal cornice at the front and back of the building is covered with tin coated steel sheet metal. There is one open seam on the west elevation, which needs to be caulked this summer with a good quality urethane sealant. The rear horizontal cornice was not accessible via the town's tree trimming lift because of the cemetery during our inspection, and should be checked by a contractor to see if a similar condition exists.

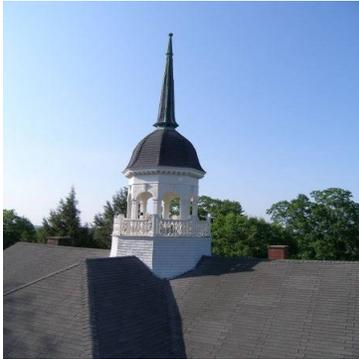
B-3 The horizontal cornice sheet metal roofing is also starting to rust. Painting is no longer effective at controlling the rust. The horizontal cornice roof should be replaced at the same time as the main roof is done with *zinc-coated* copper.

B-4 The large cupola is in fair condition. The roof of the cupola is black slate, which appears very serviceable however, on the spire section of the roof, some of the copper hips have blown off and need to be replaced. The baluster railing is in need of a comprehensive restoration; several balusters are missing and temporary repairs have been made to the decorative top rail. Because of the need for staging to be placed on the main roof, we recommend that this work be done at the same time as the main roof. There is a need for staging to be placed on the main roof; therefore, we recommend that this be implemented while replacing the main roof. Paint cupola when repairs have been completed.

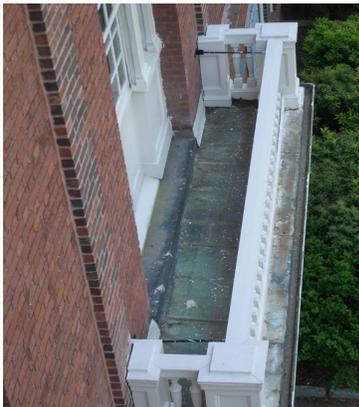
B-5 There is a rusted exhaust vent on the northeast corner of the roof, which needs to be replaced in a couple of years.

B-6 The small second floor balcony has a very old flat seam copper roof and gutter, which should be replaced at the same time as the main roof. We recommend a new flat seam copper roof as the most durable roof for this type of balcony. Some baluster and railing repairs and painting will be needed as part of the roofing work.

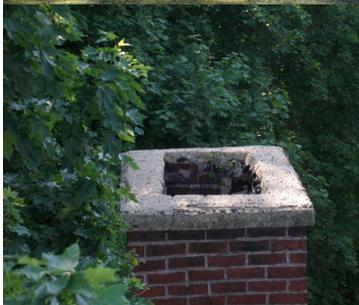
B-8 The brick chimney at the north elevation of the building has a small tree growing out of the brickwork at the top of the chimney. The mortar on the exterior of the chimney appears to be in adequate condition; however, the mortar inside the chimney near the top is in poor condition. The chimney also tilts southward, which suggests that mortar has debonded and that the chimney should be rebuilt from the roofline to the top of the chimney.

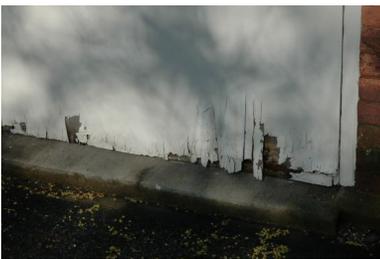
B-11 The bottom of the exterior door for the basement stair is in poor condition and needs to be replaced. Likewise, the adjoining light is not working and should be replaced.

B-12 The main roof eave cornice is very deteriorated at the southwest corner of the building, (extending several feet to the north and east) and must be dismantled and reconstructed.

B-13 The first floor windowsills, at the south elevation are deteriorated, have shifted and must be reset.

B-14 The mortar wash atop the south elevation's terra cotta "portico," has delaminated and lifted off the terra cotta. Several of the terra cotta units have cracked or chipped. The terra cotta units should be restored with patching mortars and injections adhesive and a new metal flashed mortar wash should be created atop them.

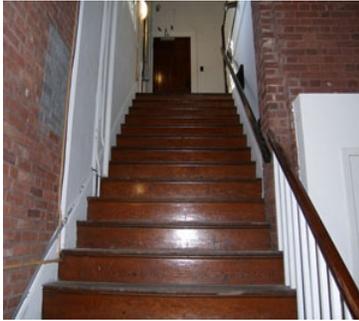
- a) Present tread and riser dimensions would be non-compliant. Existing treads are 10½", and risers are 8". (Code would require minimum 11" tread, and maximum 7" riser). This condition may be considered acceptable if the other conditions are upgraded.

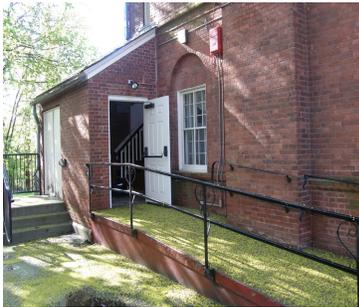
A-2 The auditorium exit door, which leads to the new enclosed exit stair, does not have panic hardware (exit device). But curiously, the door adjacent to it, which leads to the open stairway, has both an exit sign and panic hardware

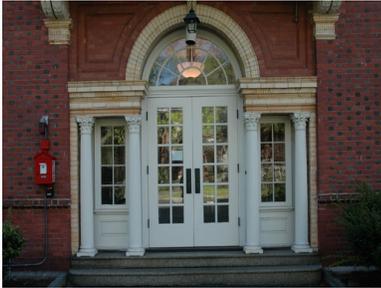
A-8 The main entrance to the building is not accessible. Since Bemis Hall houses the Council on Aging, we feel that the front door should be accessible to all users of the building of the building. Since there are only 2 steps to the front door this can be readily achieved.

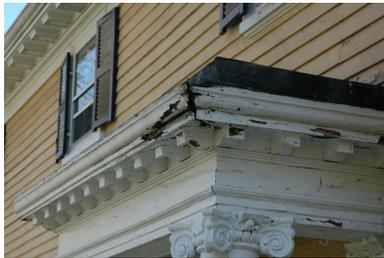
B-1 The roof above the side entrance (kitchen entrance) including associated wood gutter, fascia and soffit is in poor condition and needs to be repaired and rebuilt.

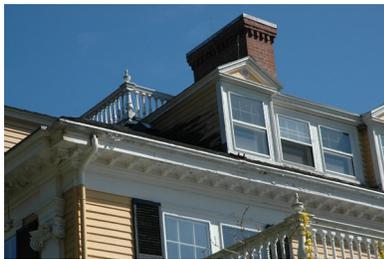
B-2 The wood gutters on the main roof are old and dried-out. They need to be cleaned and oiled every year.

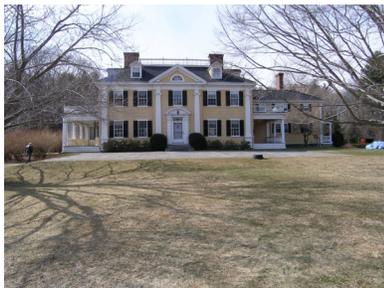
B-4 There is missing and eroded mortar on the center chimney. The chimney needs to be completely repointed and copper flashing added at both the top of the chimney and at the roofline. This work should have been completed before the recent roof was installed.

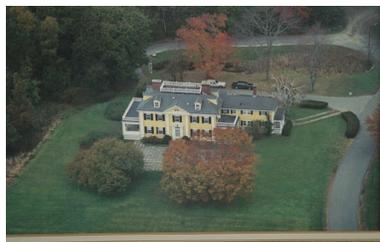
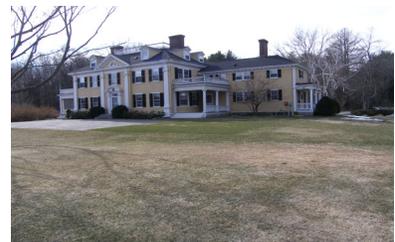
B-5 There are bees swarming at the soffit at the northwest corner of the house. An exterminator should remove or relocate these bees.

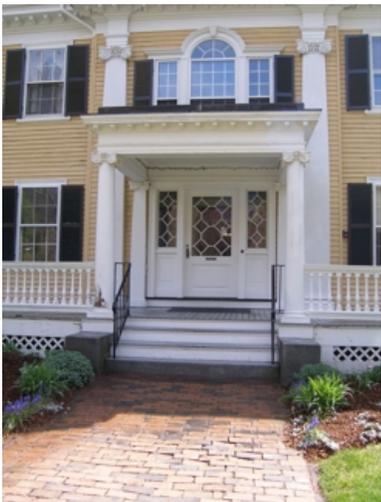
A-4 The brick paving at the main entry walk has settled causing an irregular walking surface, which can present a tripping hazard.

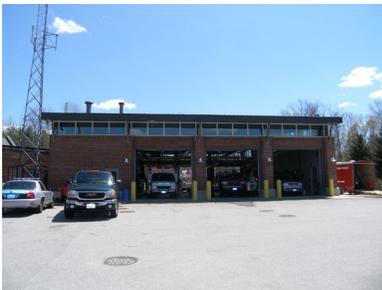
B-1 In general, the roof appears to be in good condition and is performing adequately. The roof of the Apparatus Room is arched, sloping gently front to back with large overhangs above the apparatus doors. At the building line, in these locations, are built-in gutters, which chronically leak. We were able to reproduce these leaks with a garden hose and with the assistance of the fire department. The likely cause of these leaks is the termination between the EPDM liner and the roof drain body. A representative of the drain manufacturer Zurn should meet with a qualified roofing contractor to correct this ongoing problem.

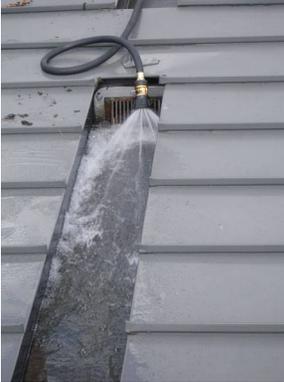
B-2 There have been chronic problems with ice dams at the rear of the Apparatus Room roof and ice sliding off the roof and freezing on the walk area below. This situation is caused by the four or five foot overhang located beyond the gutter and the gaps between the gutter sections, which allows the roof trusses to pass. In 2005, electric snow melting wires were installed near the eaves. These wires seem to have improved the situations; however, we received very little snow last year.

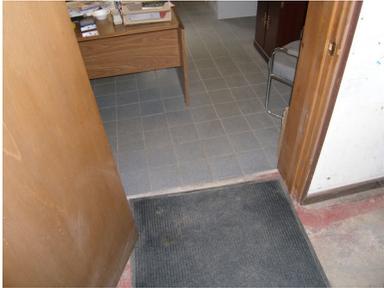
A-1 There is only one passage door that leads directly outside from the truck and equipment bays. Overhead doors are not considered an acceptable means of egress in case of fire or other emergencies. At least two new fire doors need to be added.
