**Town of Lincoln, Massachusetts
 Community Preservation Committee
 Project Submission Form**

Project Name: Pierce House

Pierce House

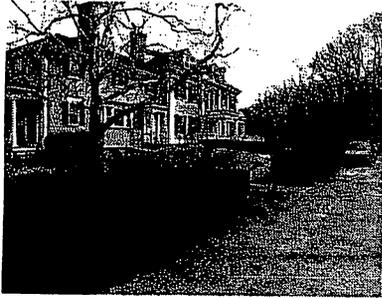
B-5 There are bees swarming at the soffit at the northwest corner of the house. An exterminator should remove or relocate these bees.

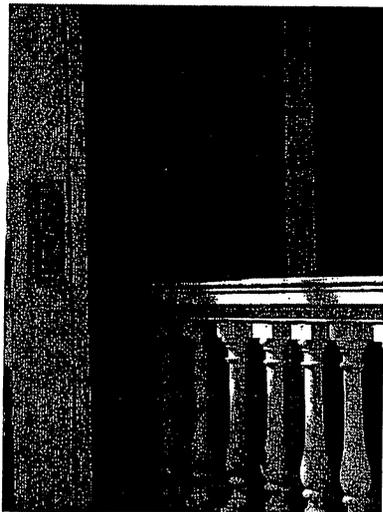
B-6 The following exposed elements were found to be rotted or damaged:

- The north eave rake on the west elevation's center entry bay, there is a rotted hole in the bottom in the northwest corner of the house's main section and the main west entry pediment pitches southward, suggesting rotted conditions below.

- The south column is split and the entablature is rotting at the north wing's west entrance.
- The bottoms of three columns at the north elevation are damaged- two have rotted and one has split.

- At the east elevation, the trim-work where the pilasters at each side of the central doorway step are rotted, along with the water-table at the northeast corner of the main section of the house, and the base of the northeast porch's corner column.

- One of the columns in the north porch is partially rotted and split and another has a rotted base.
- The widow's walk railing is in need of selective repairs. The rotted wooden components should be replaced and all split columns should be replaced or repaired, depending upon the condition of the wood and the causes of the splits.

B-7 After the repairs noted above are completed, the exterior of the house will need to be repainted.

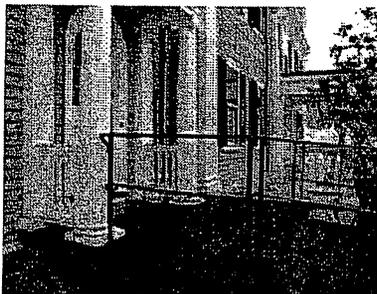
A-1 While there presently is a ramp on the main entry side of the building, it is not compliant with the Requirements of the Architectural Access Board. The ramp has railings in only one side. The ramp provides accessibility to the porch, but there is still a 6" high step, which prevents access to the main floor. We recommend that the wood porch be rebuilt to slope from the brick side entrance porch elevation to the first

floor elevation at the main door. The wood porch beyond the main door should also be raised to first floor elevation.

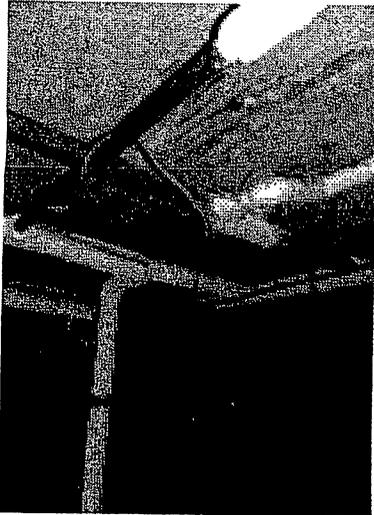
suggesting compressed downward onto the supporting wooden sill. The sill should be exposed and replaced along with the bottoms of studs and posts that bear on it if found to rotted.

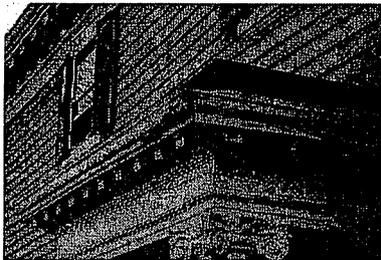
B-1 The roof above the side entrance (kitchen entrance) including associated wood gutter, fascia and soffit is in poor condition and needs to be repaired and rebuilt.

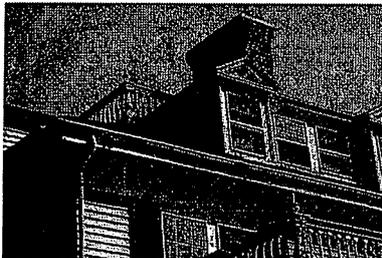
B-2 The wood gutters on the main roof are old and dried-out. They need to be cleaned and oiled every year.

B-3 In a few years, these wood gutters will need to be replaced with new cedar gutters.

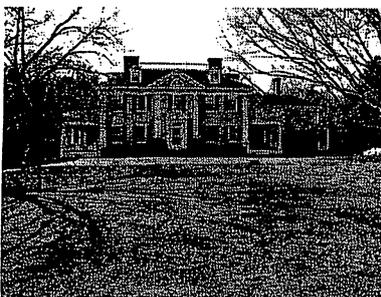
B-4 There is missing and eroded mortar on the center chimney. The chimney needs to be completely repointed and copper flashing added at both the top of the chimney and at the roofline. This work should have been completed before the recent roof was installed.

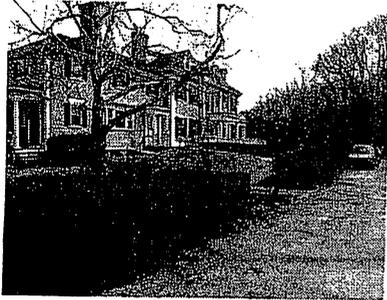
B-5 There are bees swarming at the soffit at the northwest corner of the house. An exterminator should remove or relocate these bees.

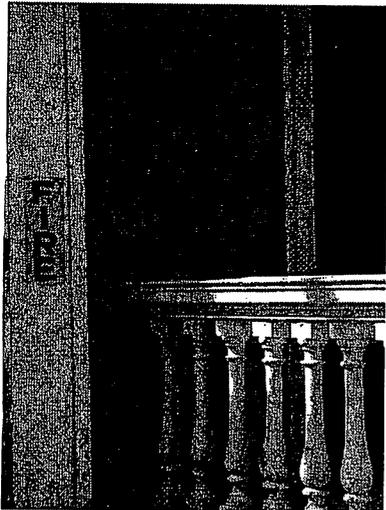
B-6 The following exposed elements were found to be rotted or damaged:

- The north eave rake on the west elevation's center entry bay, there is a rotted hole in the bottom in the northwest corner of the house's main section and the main west entry pediment pitches southward, suggesting rotted conditions below.

- The south column is split and the entablature is rotting at the north wing's west entrance.
- The bottoms of three columns at the north elevation are damaged- two have rotted and one has split.

- One of the columns in the north porch is partially rotted and split and another has a rotted base.
- The widow's walk railing is in need of selective repairs. The rotted wooden components should be replaced and all split columns should be replaced or repaired, depending upon the condition of the wood and the causes of the splits.

B-7 After the repairs noted above are completed, the exterior of the house will need to be repainted.

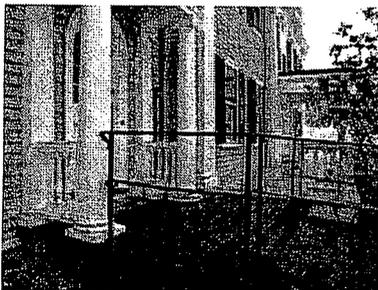
A-1 While there presently is a ramp on the main entry side of the building, it is not compliant with the Requirements of the Architectural Access Board. The ramp has railings in only one side. The ramp provides accessibility to the porch, but there is still a 6" high step, which prevents access to the main floor. We recommend that the wood porch be rebuilt to slope from the brick side entrance porch elevation to the first

floor elevation at the main door. The wood porch beyond the main door should also be raised to first floor elevation.
