To: Capital Planning Committee, Library Trustees
From: Barbara Myles
Date: December 6, 2005
Subject: Replies to Questions on Library Windows from the Capital Planning Committee Meeting on November 29, 2005

Description: Gund building window replacement project – budget price estimates

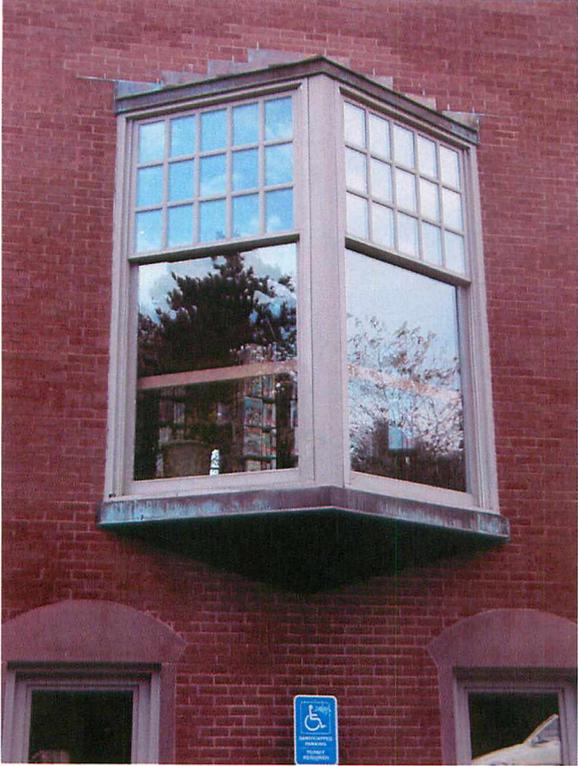
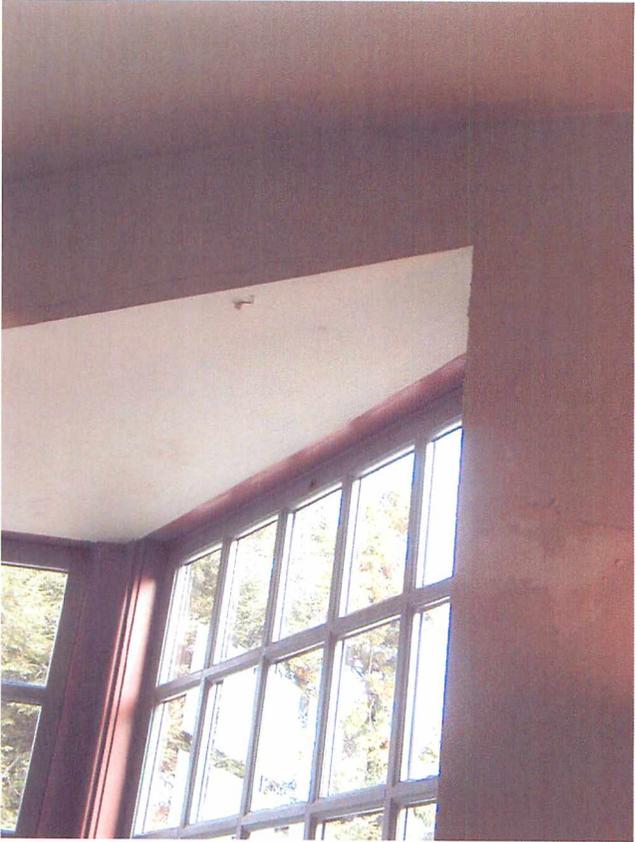
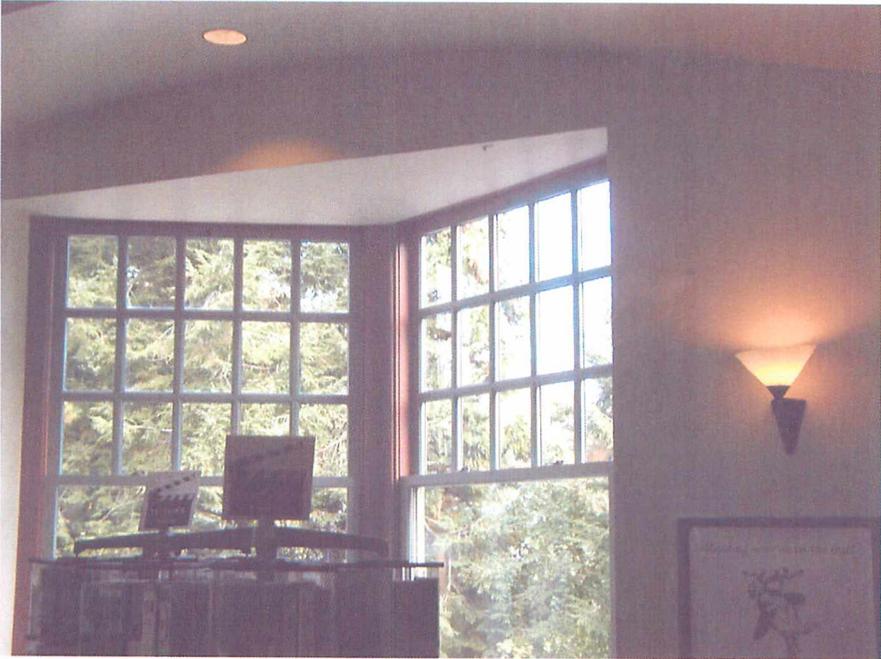
October 18, 2005

The Children's Room floor to ceiling window above the handicapped parking area has visible rot at the lower left corner of the exterior of the window and peeling paint on its interior.

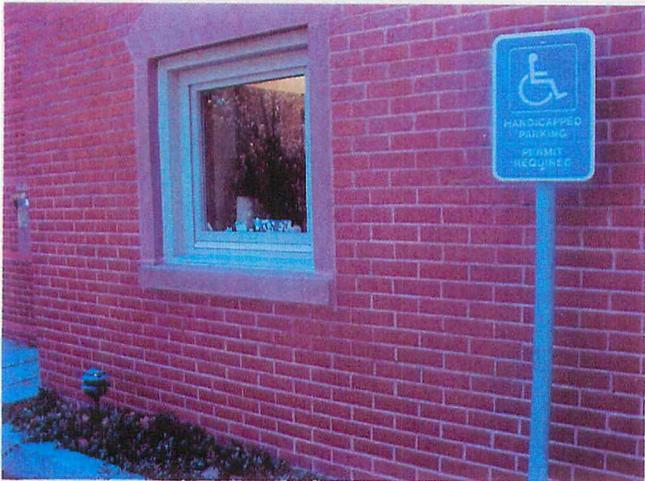
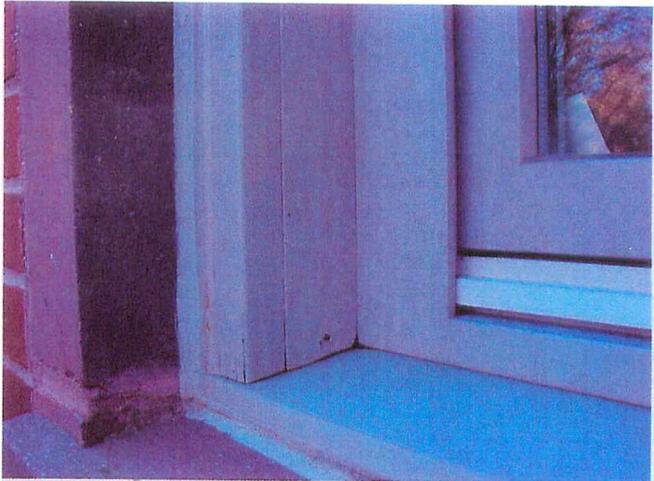
November 7, 2003

Office windows - rot is found in the lower comers

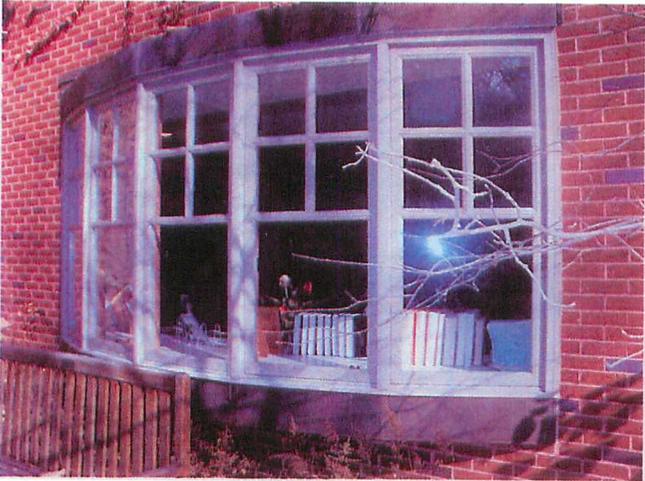
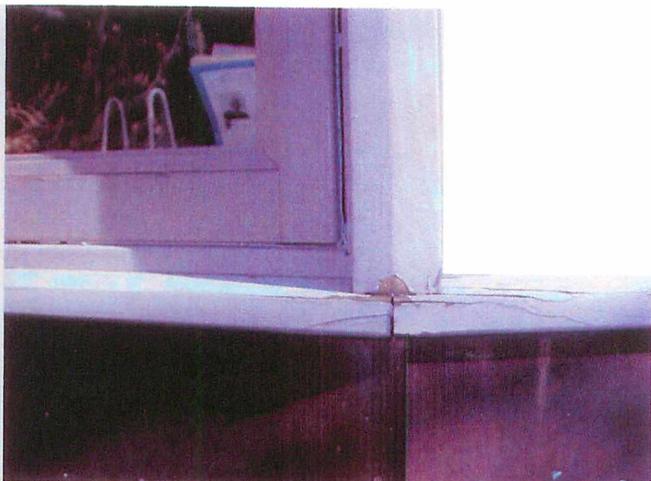
Reference Room bay window - the plastic coating is deteriorating and rot is found in the sill area.

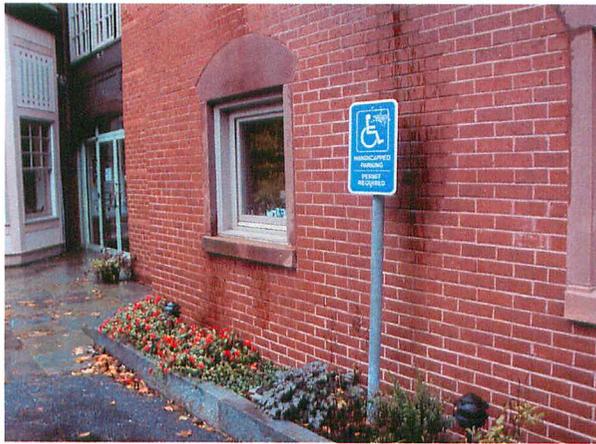
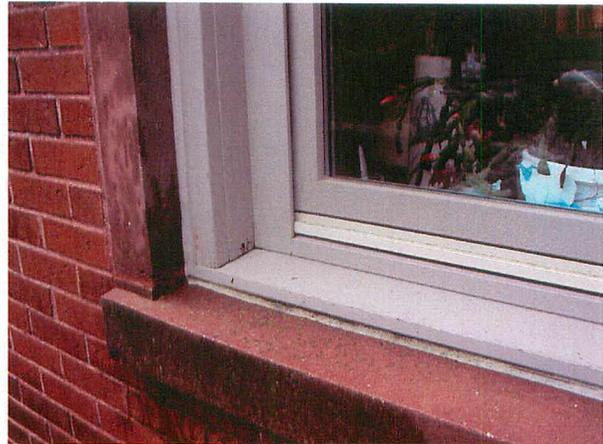
October 18, 2004

Office windows – rot is found in lower corners

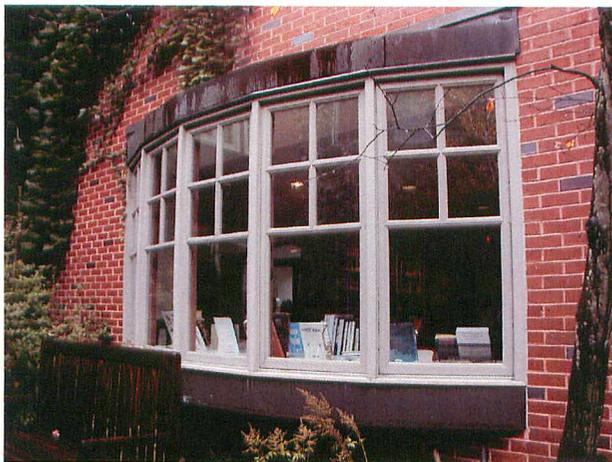
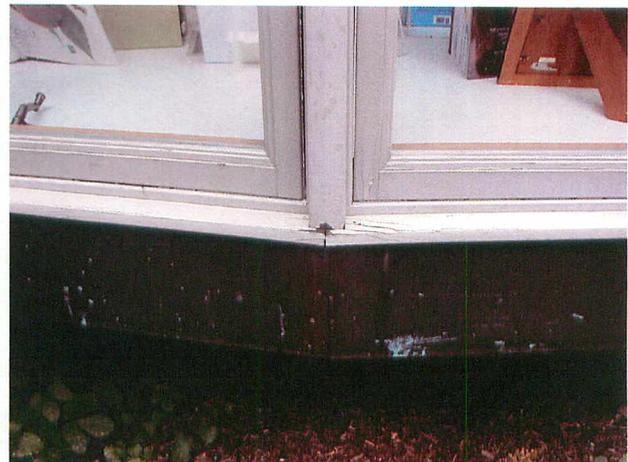
Reference Room bay window – the plastic coating is deteriorating and rot is found in the sill area.

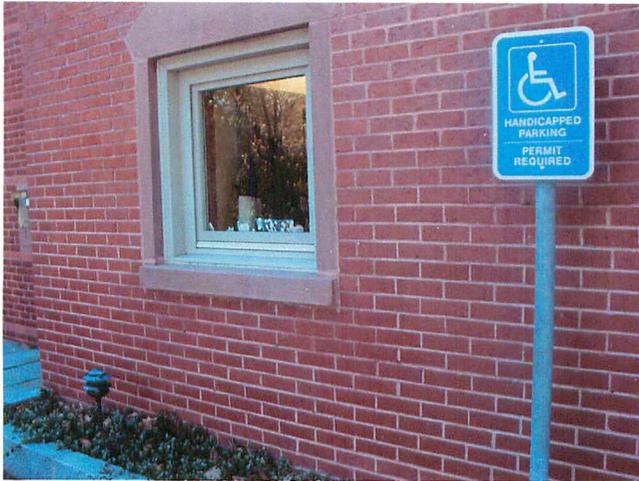
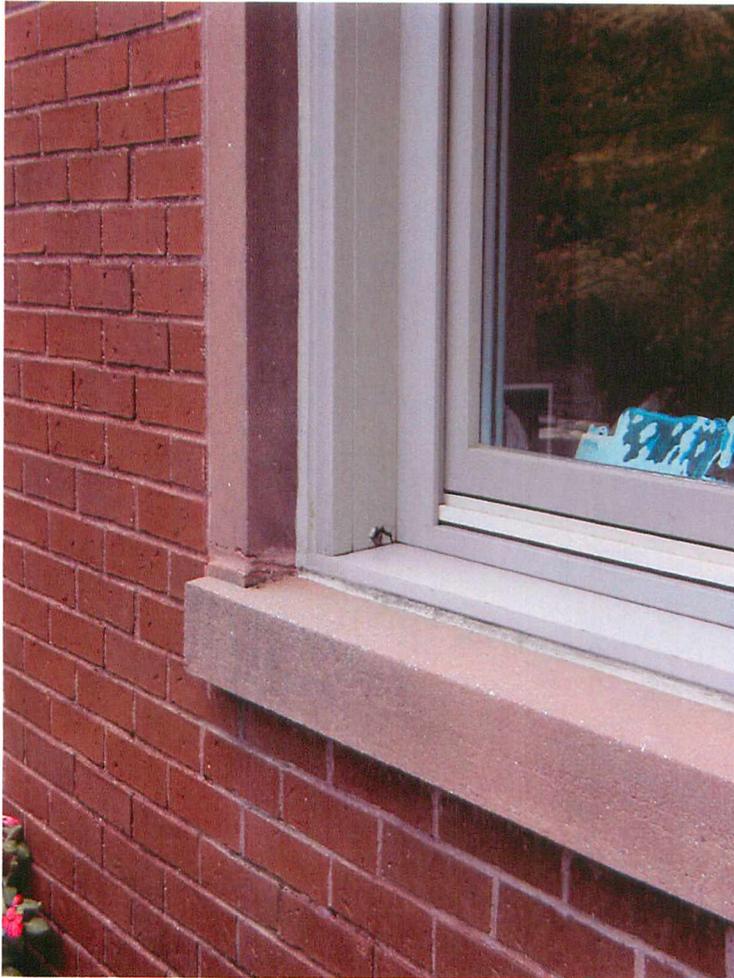
October 18, 2005

Office windows – rot is found in the lower corners

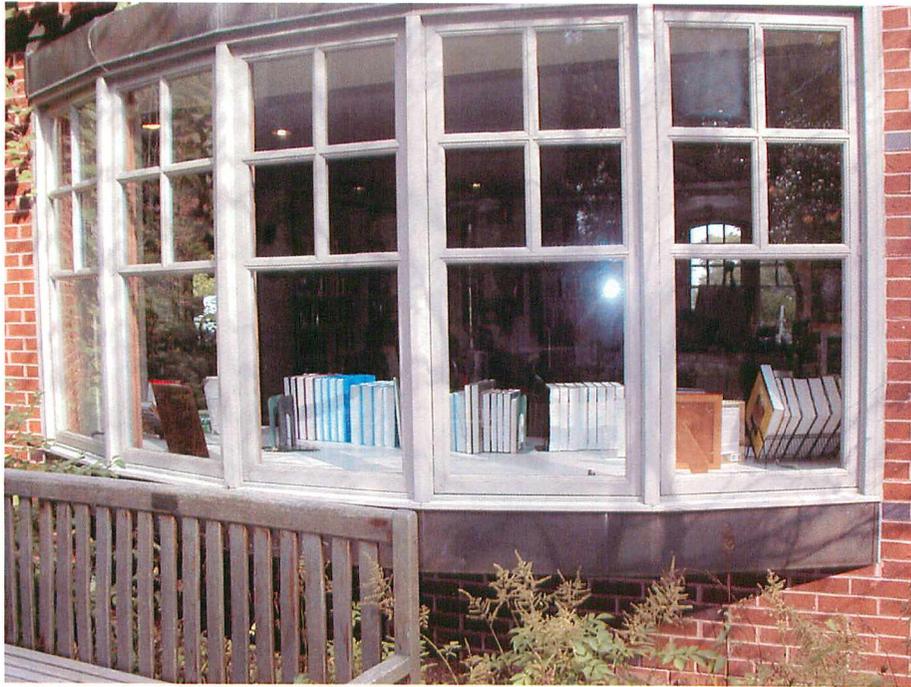
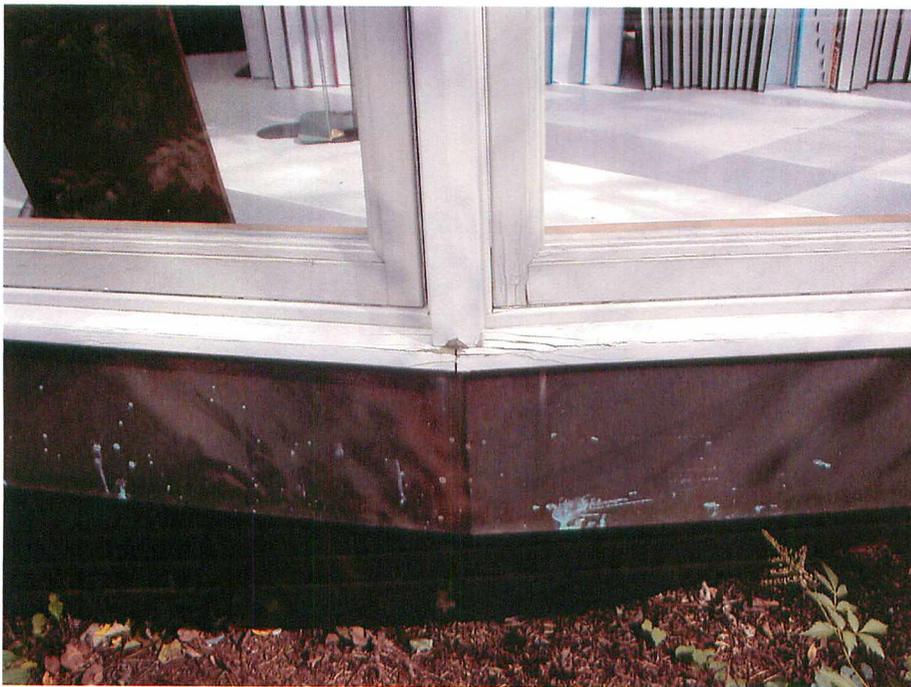
October 18, 2005

Reference Room bay window – the plastic coating is deteriorating and rot is found in the sill area.

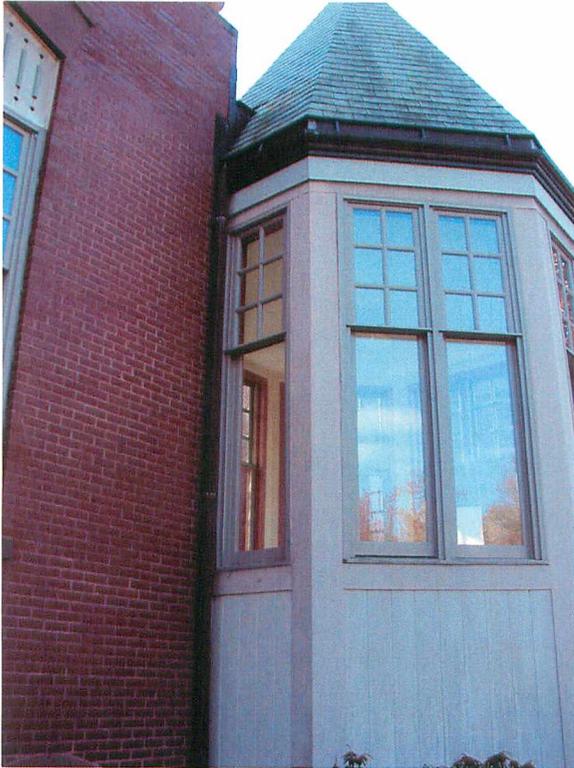
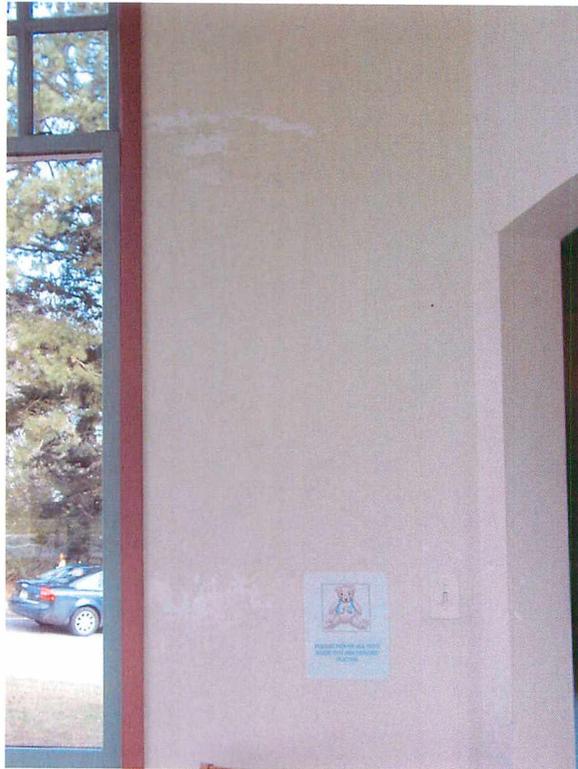
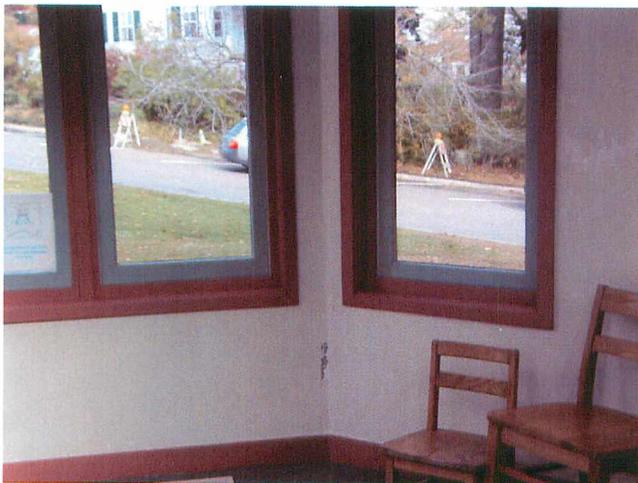
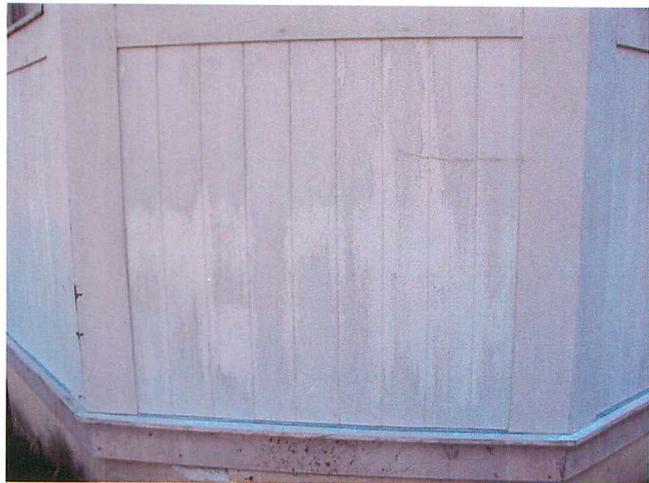
November 7, 2003

Children's Room turret – flashing problems causing paint to peel, plaster to crack on the inside of the turret, and mold to grow on the outside of the turret.

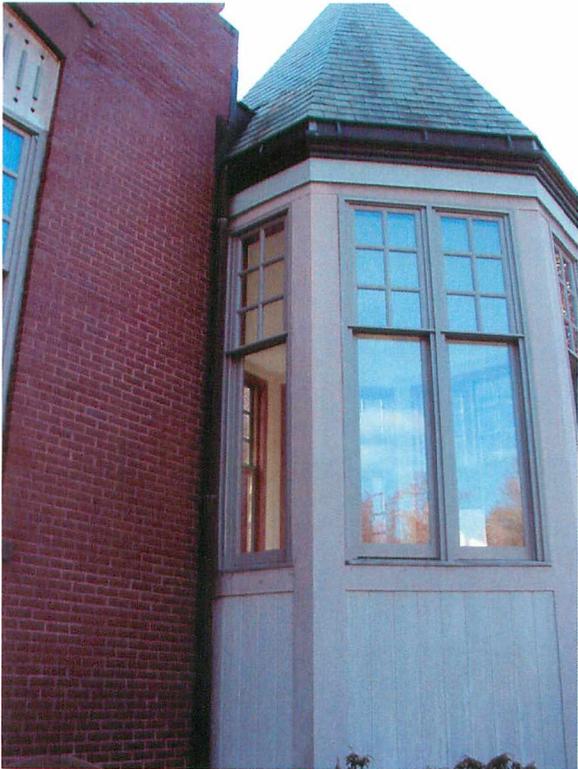
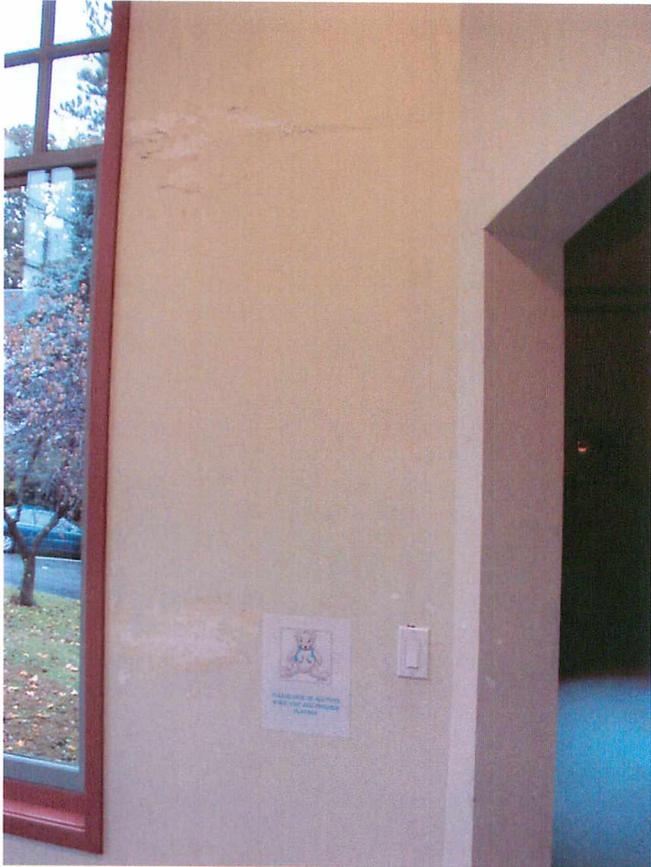
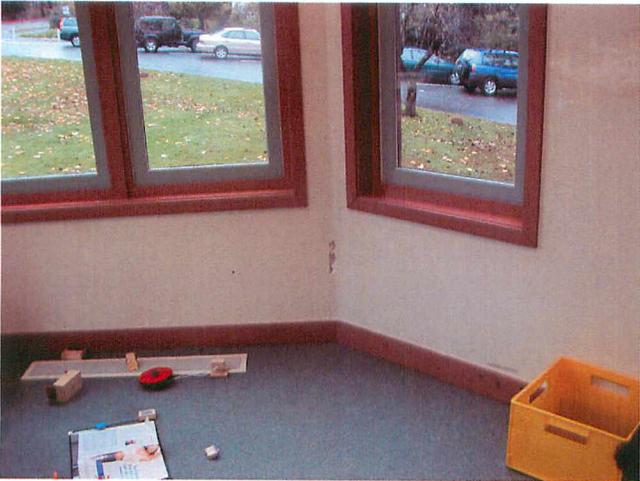
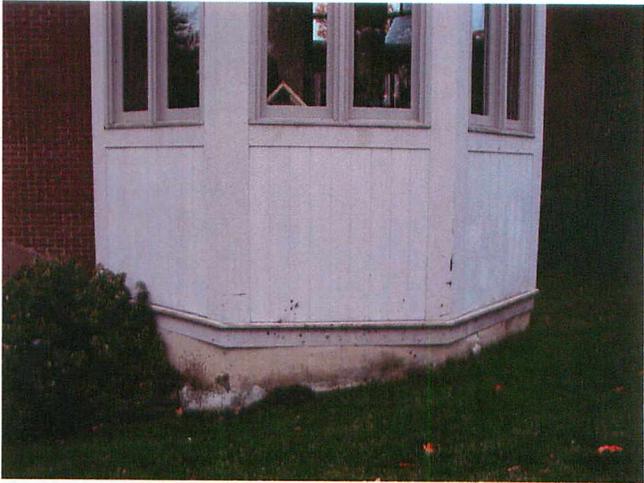
October 18, 2004

Children's Room turret – flashing problems causing paint to peel, plaster to crack on the inside of the turret, and mold to grow on the outside of the turret.

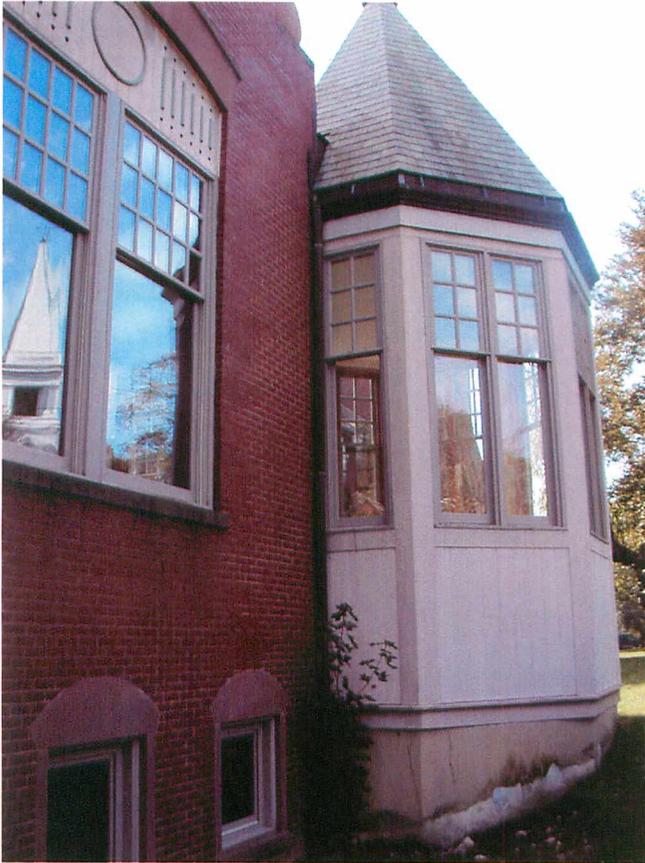
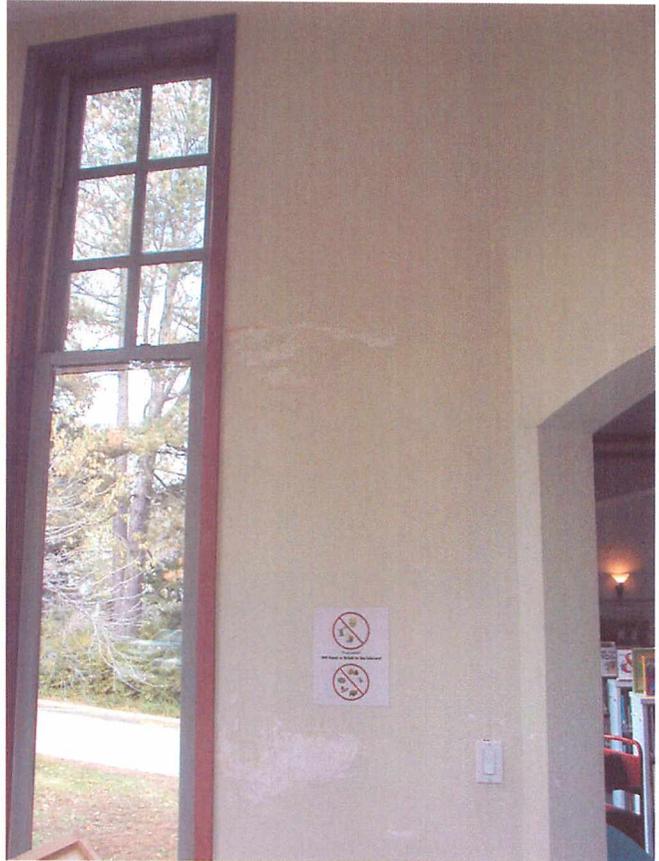
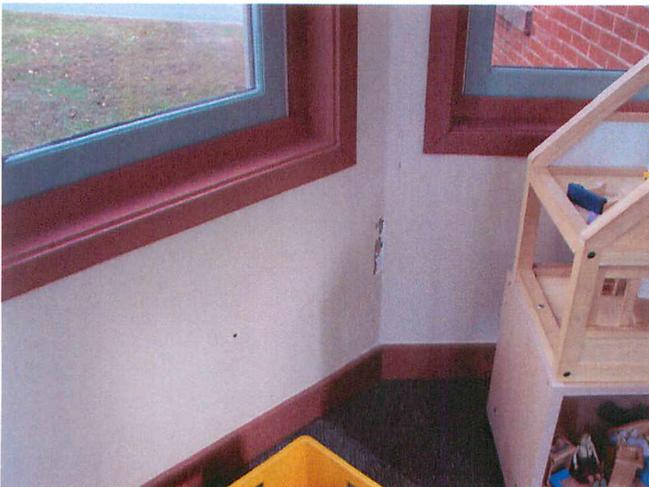
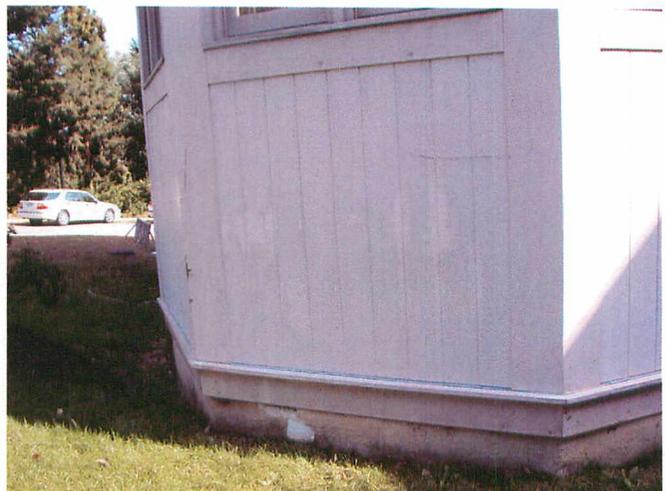
October 18, 2005

Children's Room turret – flashing problems causing paint to peel, plaster to crack on the inside of the turret, and mold to grow on the outside of the turret.

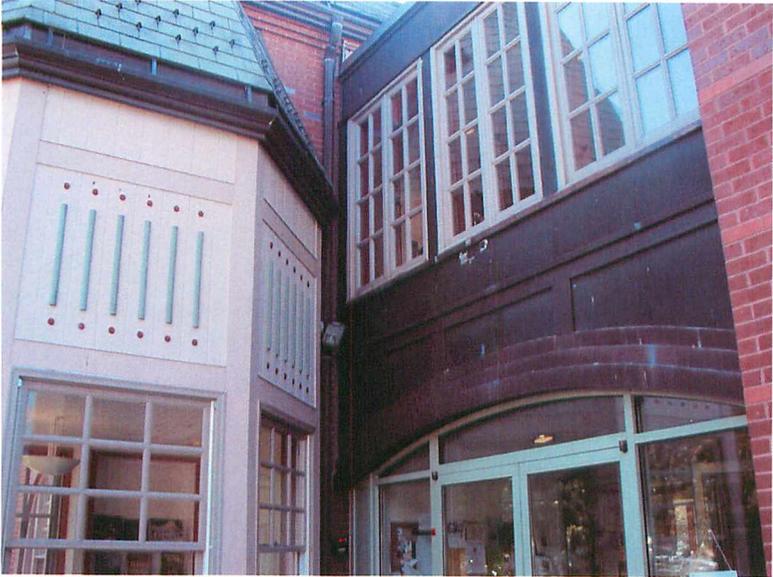
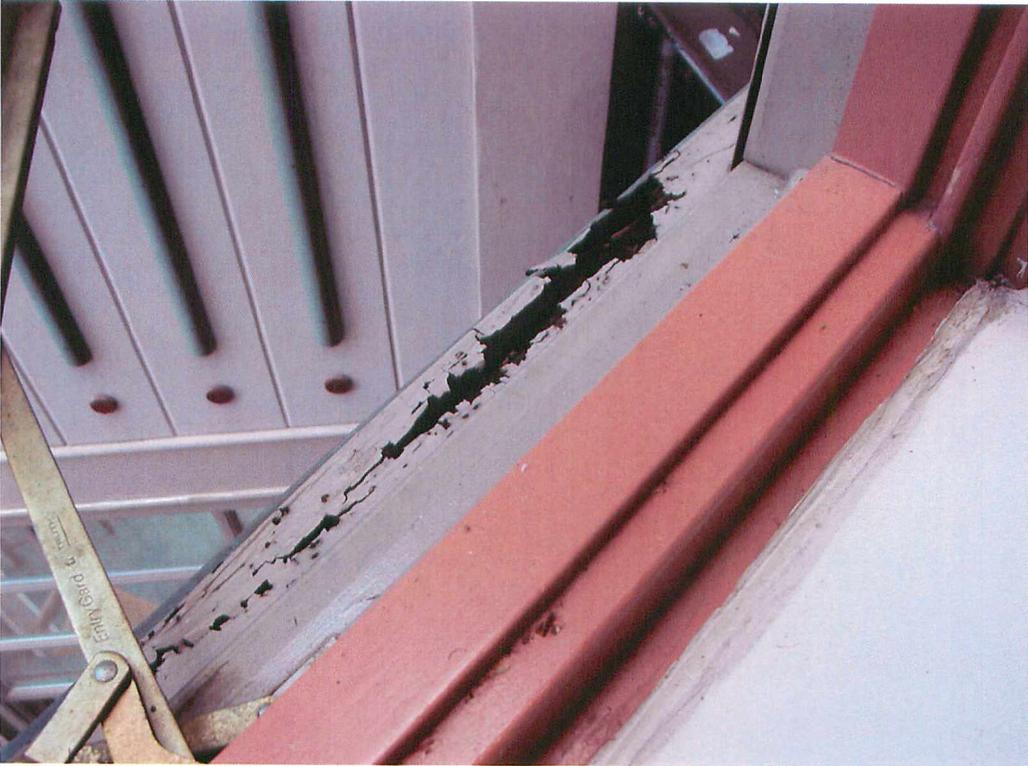
November 7, 2003

Children's Room above the library entrance – the design of the turret causes water to flow directly onto the windows above the library entrance.

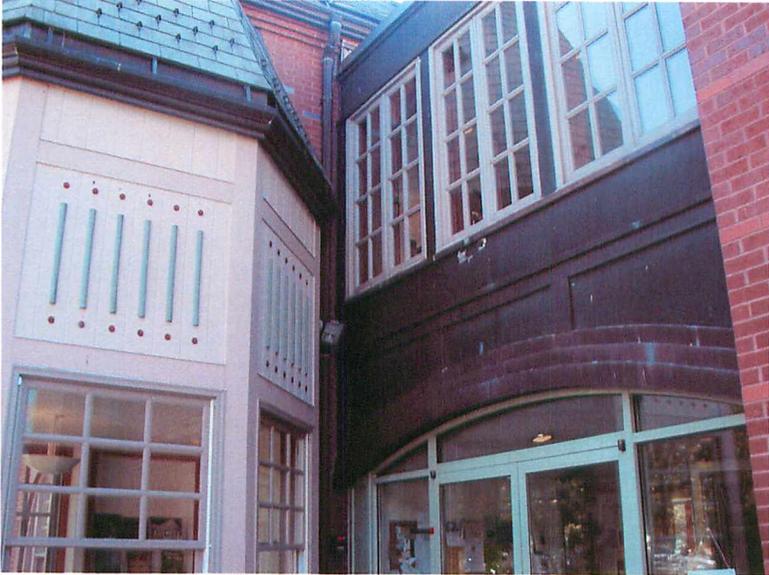
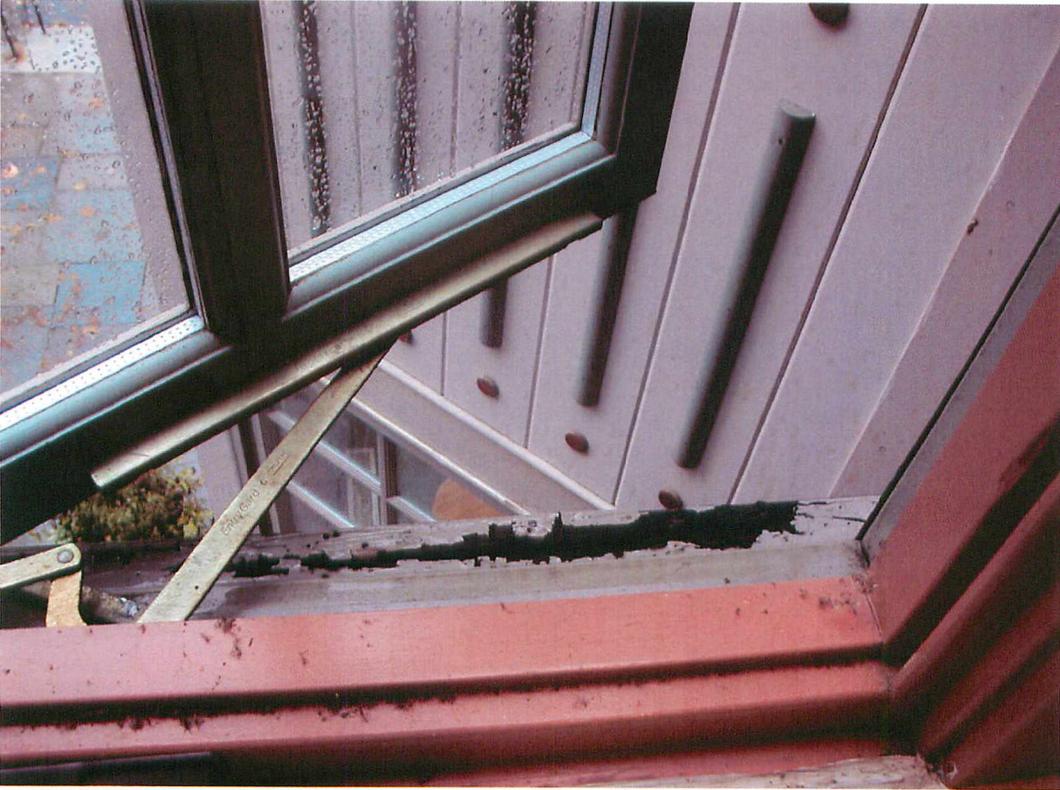
October 18, 2004

Children's Room above the library entrance – the design of the turret causes water to flow directly onto the windows above the library entrance.

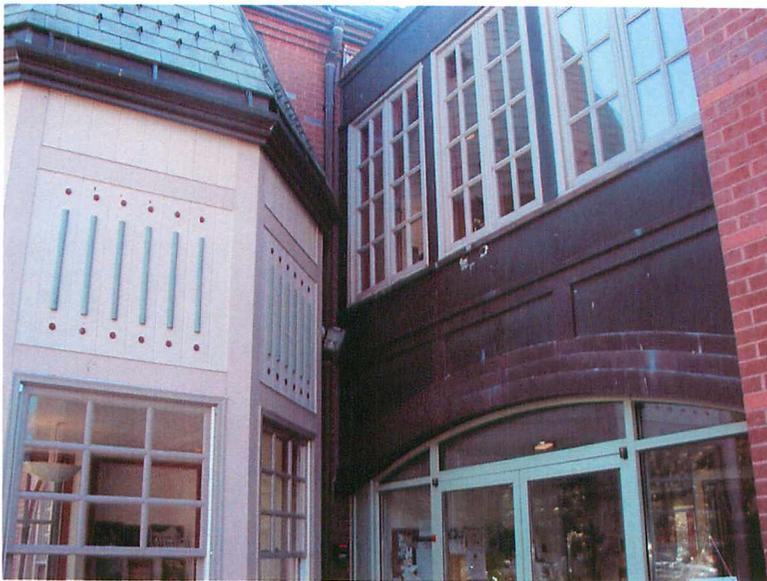
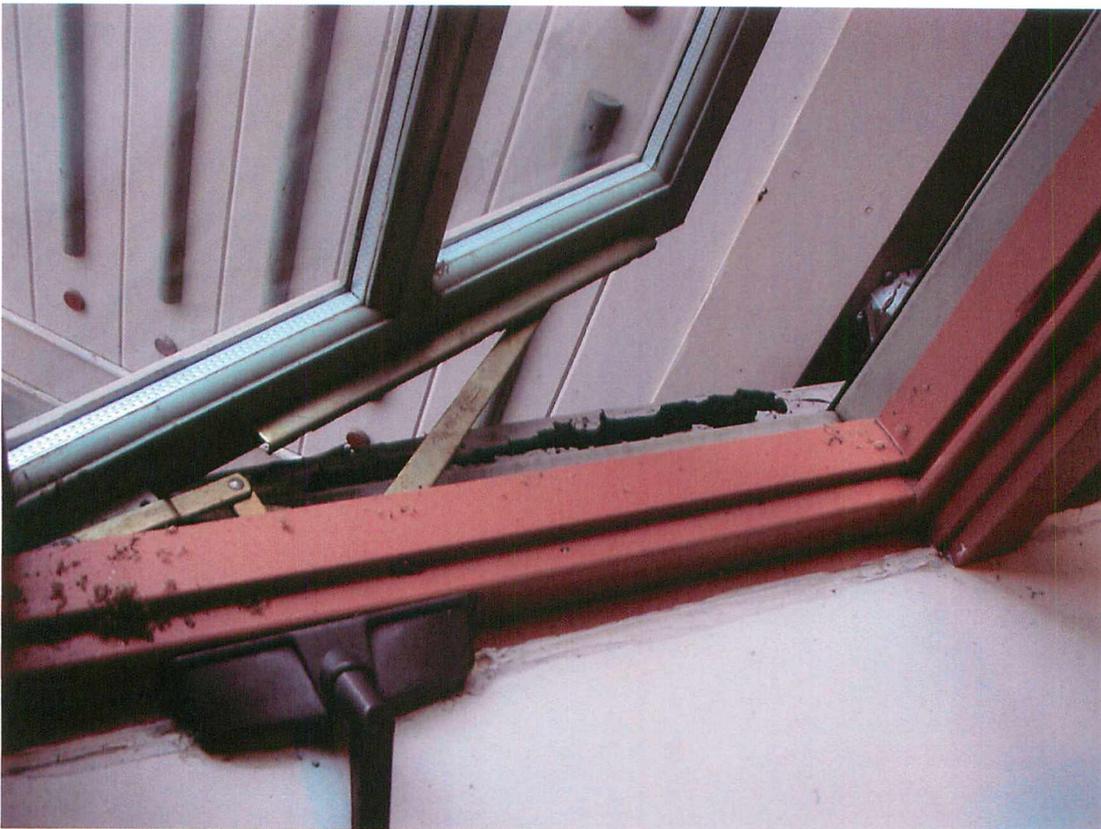
October 18, 2005

Children's Room above the library entrance – the design of the turret causes water to flow directly onto the windows above the library entrance.
