Town of Lincoln

Building Needs Assessment

July 24, 2006

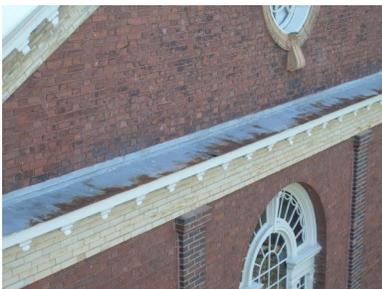
B-2 The horizontal cornice at the front and back of the building is covered with tin coated steel sheet metal. There is one open seam on the west elevation, which needs to be caulked this summer with a good quality urethane sealant. The rear horizontal cornice was not accessible via the town's tree trimming lift because of the cemetery during our inspection, and should be checked by a contractor to see if a similar condition exists.

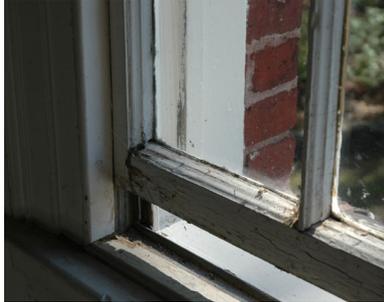
B-20 Most windows in Bemis Hall are single glazed double hung windows, which appear to be original to the building with mostly original glass. Four office windows have full wood storms. Many half screen or screen inserts can be seen on other windows. The window sashes are in average condition. Many of the top sash have been painted shut. One Assembly Hall sash has been badly modified from a double hung window to a fixed sash and caulked on both sides. This one window will need to be replaced in the next 5-10 years.

Triple track exterior aluminum storm windows are recommended for all windows. Storm windows will reduce heat loss and energy costs and help preserve the original windows. Before installing storm windows, the upper sash should be freed and the entire window repainted.

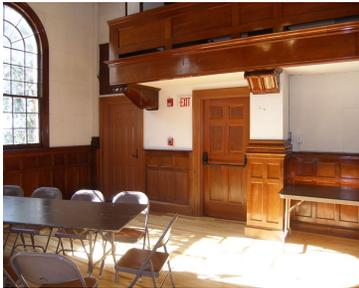
A-2 The auditorium exit door, which leads to the new enclosed exit stair, does not have panic hardware (exit device). But curiously, the door adjacent to it, which leads to the open stairway, has both an exit sign and panic hardware

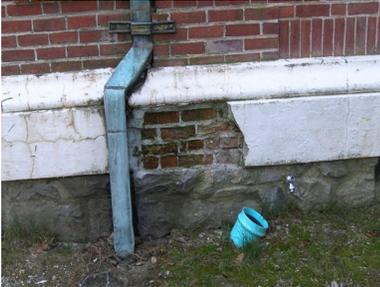
B-2 There is a cement stucco-covered brick step, or watertable that rings the top of the foundation and makes a transition from stonework below to brickwork above. The stucco is cracked and starting to spall, exposing the brick below, which is starting to deteriorate. This is occurring in these areas:

- There are vertical cracks in the stucco for much of the north elevation and a chunk of it is missing at the center of its eastern bay.
- There is a large spall in the stucco watertable at the southeast corner of the building, and a smaller hole in at the southeast corner of the south projecting bay.
- The stucco watertable has frequently occurring vertical cracks along most of the south elevation.
- The stucco is ready to spall at the southwest corner of the building and it is chipped at the southeast corner of the south projecting bay.
- The stucco is vertically cracked in random locations on the west elevation.

The stucco coating on the watertable should be hammer tested and inspected. All loose delaminating stucco should be removed, along with all deteriorated brick substrate below, and the stucco should be re-applied to the removed areas. Consideration should be given to provide metal flashing to protect the watertable and prevent this condition from reoccurring.

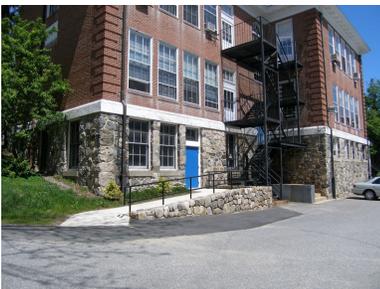
A-1 There is no accessibility to the second floor.

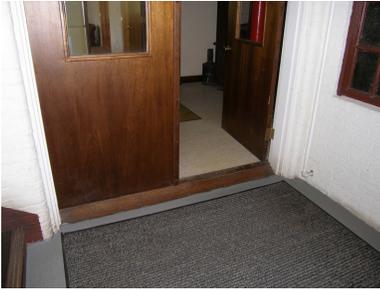
A-2 A ramp was built outside of the meeting room, at the basement level, presumably to provide accessibility. This ramp has a one-sided railing, and it leads to a door, which has no accessible hardware. A newly remodeled toilet room, which provides all of the necessary code compliant (e.g. fixtures, clearances, and mounting heights), is rendered inaccessible to the meeting room due to a floor level change approximately 4”.

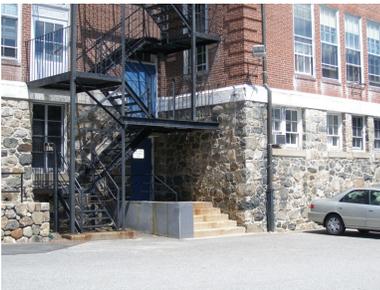
A-3 Egress from the building is via open stairs (i.e. no fire rated vertical separation of floors) and fire escapes at the rear of the building. The fire escapes presently have no means of prevention of snow or ice accumulation. Former doors that provided exit to the fire escapes, at the mid-level, between the basement and on the first floor have been permanently closed off. In sum, the code will allow this type of egress system in an existing building, but it would not be permitted in new construction.

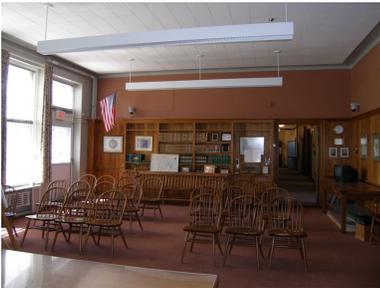
A-6 At the first floor meeting room, the interior storm door that has been installed prevents the door from functioning as an exit, so the exit sign attached there is in the wrong location. The exit sign should be attached over the door that leads to the main corridor.

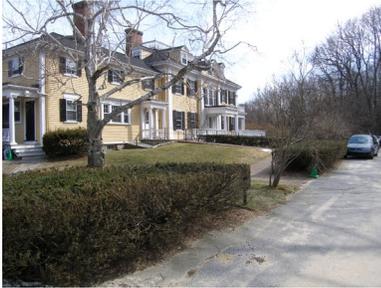
B-5 There are bees swarming at the soffit at the northwest corner of the house. An exterminator should remove or relocate these bees.

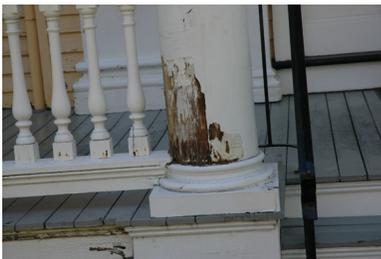
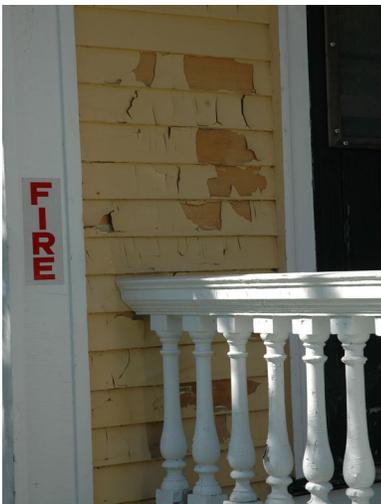
B-6 The following exposed elements were found to be rotted or damaged:

- The north eave rake on the west elevation's center entry bay, there is a rotted hole in the bottom in the northwest corner of the house's main section and the main west entry pediment pitches southward, suggesting rotted conditions below.

- The south column is split and the entablature is rotting at the north wing's west entrance.
- The bottoms of three columns at the north elevation are damaged- two have rotted and one has split.

- At the east elevation, the trim-work where the pilasters at each side of the central doorway step are rotted, along with the water-table at the northeast corner of the main section of the house, and the base of the northeast porch's corner column.

- One of the columns in the north porch is partially rotted and split and another has a rotted base.
- The widow's walk railing is in need of selective repairs. The rotted wooden components should be replaced and all split columns should be replaced or repaired, depending upon the condition of the wood and the causes of the splits.

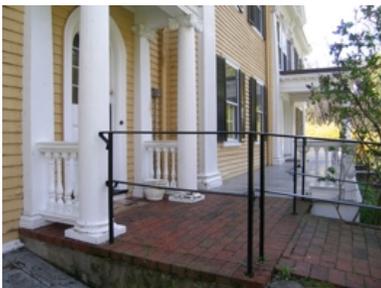
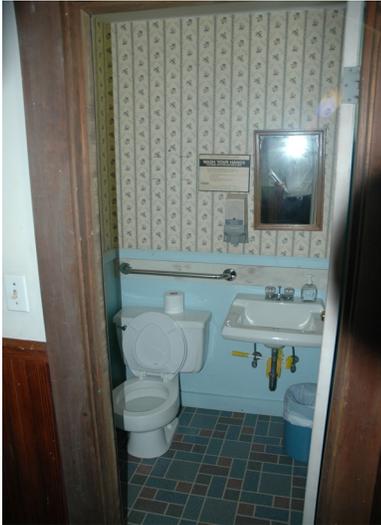
A-1 While there presently is a ramp on the main entry side of the building, it is not compliant with the Requirements of the Architectural Access Board. The ramp has railings in only one side. The ramp provides accessibility to the porch, but there is still a 6" high step, which prevents access to the main floor. We recommend that the wood porch be rebuilt to slope from the brick side entrance porch elevation to the first

floor elevation at the main door. The wood porch beyond the main door should also be raised to first floor elevation.

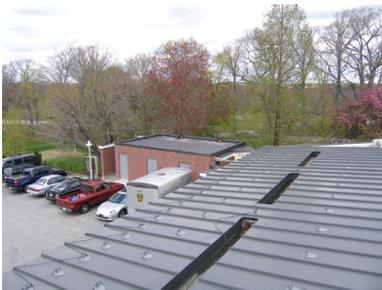
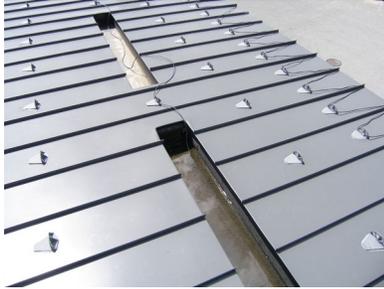
B-2 There have been chronic problems with ice dams at the rear of the Apparatus Room roof and ice sliding off the roof and freezing on the walk area below. This situation is caused by the four or five foot overhang located beyond the gutter and the gaps between the gutter sections, which allows the roof trusses to pass. In 2005, electric snow melting wires were installed near the eaves. These wires seem to have improved the situations; however, we received very little snow last year.

Typically snow melting wires only last a few years and require frequent repairs and adjustments to keep them

working. We recommend that this solution be observed for another winter or two since the only two likely alternatives is adding an additional gutter at the eave, which will likely need snow and ice melting wiring to work consistently.

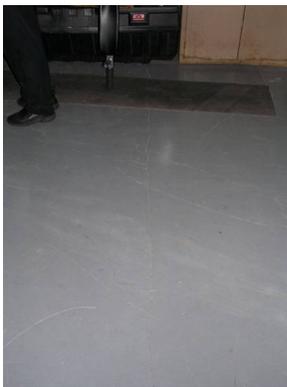
- S-1 There are cracks in the concrete fire apparatus bay floor slab near the building’s northwest corner. These are most likely the result of some limited soil settlement below the slab and/or curing shrinkage in the concrete and are not a safety concern. The crack should be cleaned and injected with adhesive.

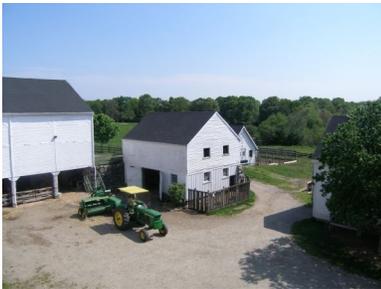
- B-1 There are several areas of concern on the exterior woodwork. These are as follow:
 - o Rotten vertical trim boards and sheathing at two interior bent locations on the north elevation and at the northwest corner. Our resistograph found the structural members to be sound behind these areas. All rotten woodwork should be replaced.
 - o There are two holes in the east elevation where clapboards are broken or missing. The holes should be patched.
 - o The lower extent of the west elevation wood siding is in physical contact with the grade and should be protected or the ground lowered or moved away.

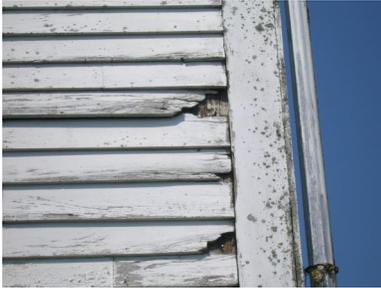
B-1 There are rotted trim boards at the northwest and southeast corners and a rotted hole with a bird living in it at the south elevation's loft-level windowsill. The rotten wood should be replaced.

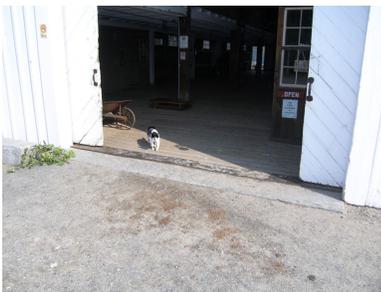
S-8 Several of the drive bay level joists have what appears to be wood-bee damage. This should be investigated to determine whether they are active, and the extent of damage.

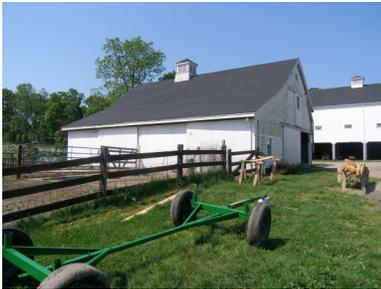
S-1 The loft floor joists serve as collar ties to restrain the roof and are connected to the rafters with long nails that protrude from their far sides. The protruding nails should be clinched.
