**Town of Lincoln, Massachusetts
 Community Preservation Committee
 Project Submission Form**

Project Name: Pierce House

Pierce House

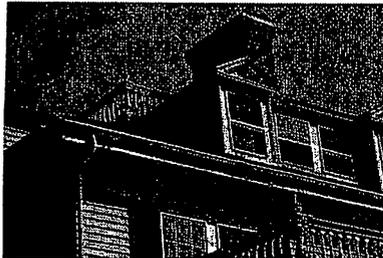
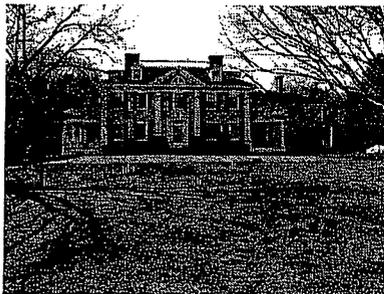
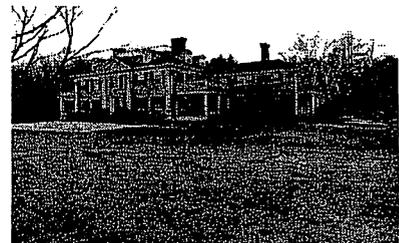
- B-1 The roof above the side entrance (kitchen entrance) including associated wood gutter, fascia and soffit is in poor condition and needs to be repaired and rebuilt.
- B-2 The wood gutters on the main roof are old and dried-out. They need to be cleaned and oiled every year.
- B-3 In a few years, these wood gutters will need to be replaced with new cedar gutters.
- B-4 There is missing and eroded mortar on the center chimney. The chimney needs to be completely repointed and copper flashing added at both the top of the chimney and at the roofline. This work should have been completed before the recent roof was installed.

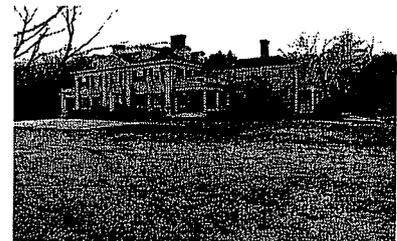
B-4 There is missing and eroded mortar on the center chimney. The chimney needs to be completely repointed and copper flashing added at both the top of the chimney and at the roofline. This work should have been completed before the recent roof was installed.
