**Town Offices  
TOWN OF LINCOLN**

**BUILDING NEEDS ASSESSMENT UPDATE and  
COMPREHENSIVE PLANNING OPTIONS**

**Bemis Hall and Town Offices**

**February 2008**

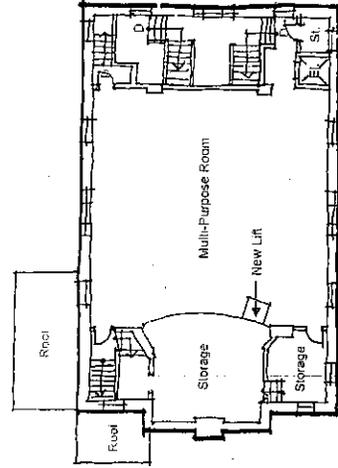
Second Level

Bemis Hall - Option A

Option Minimal Renovations:  
Focuses on Accessibility & Basic Code Compliance

- + Redesigning entry drop off and HC parking
- + Accessible Main entry raised with no stairs
- + Historic character intact
- + Improved landscape and pathways
- + Ramp on side can be removed
- + New ADA compliant men's and women's toilet rooms (also meet fixture requirements)
- + New Mechanical, Electrical, and Plumbing systems option
- +/- Redesigning Kitchen - accessible but smaller
- +/- New egress stair from basement
- +/- Possible finished space in basement
- +/- HC lift provides access to platform at multi-purpose room.
- Loss of parking spaces

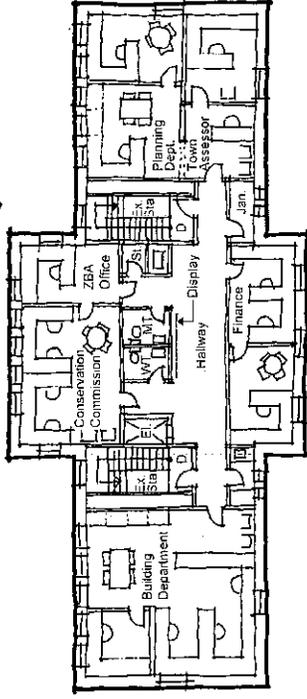
Second Level

Town Offices – Option A

Town Offices - Option A is a renovation project that maintains the current floor area of the building. It provides additional program space and corrects functional deficiencies in the building. Its estimated construction cost is \$5,214,000 including A&E fees or \$1,690,000 more than the Town Offices incremental costs. Major improvements include providing fully accessible entries at the Lower Level, a clear and efficient circulation system, a Lower Level corridor to connect both sides of the building at this level, enclosed existing stairs, core spaces including an elevator, janitors closets, accessible restrooms, new mechanical and electrical systems, and thermally efficient and architectural replacement windows.

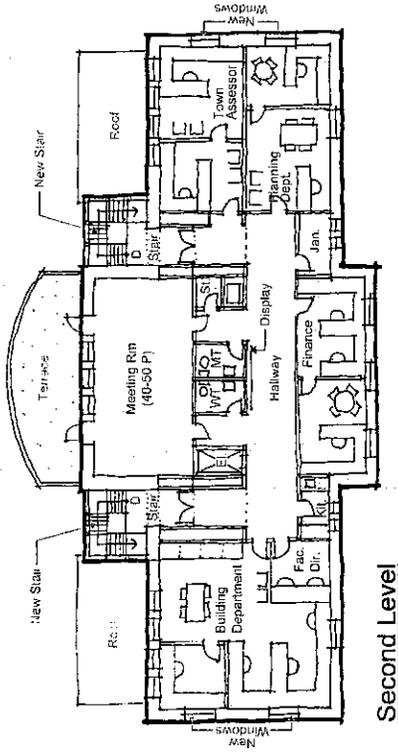
Second Level

Town Offices – Option B

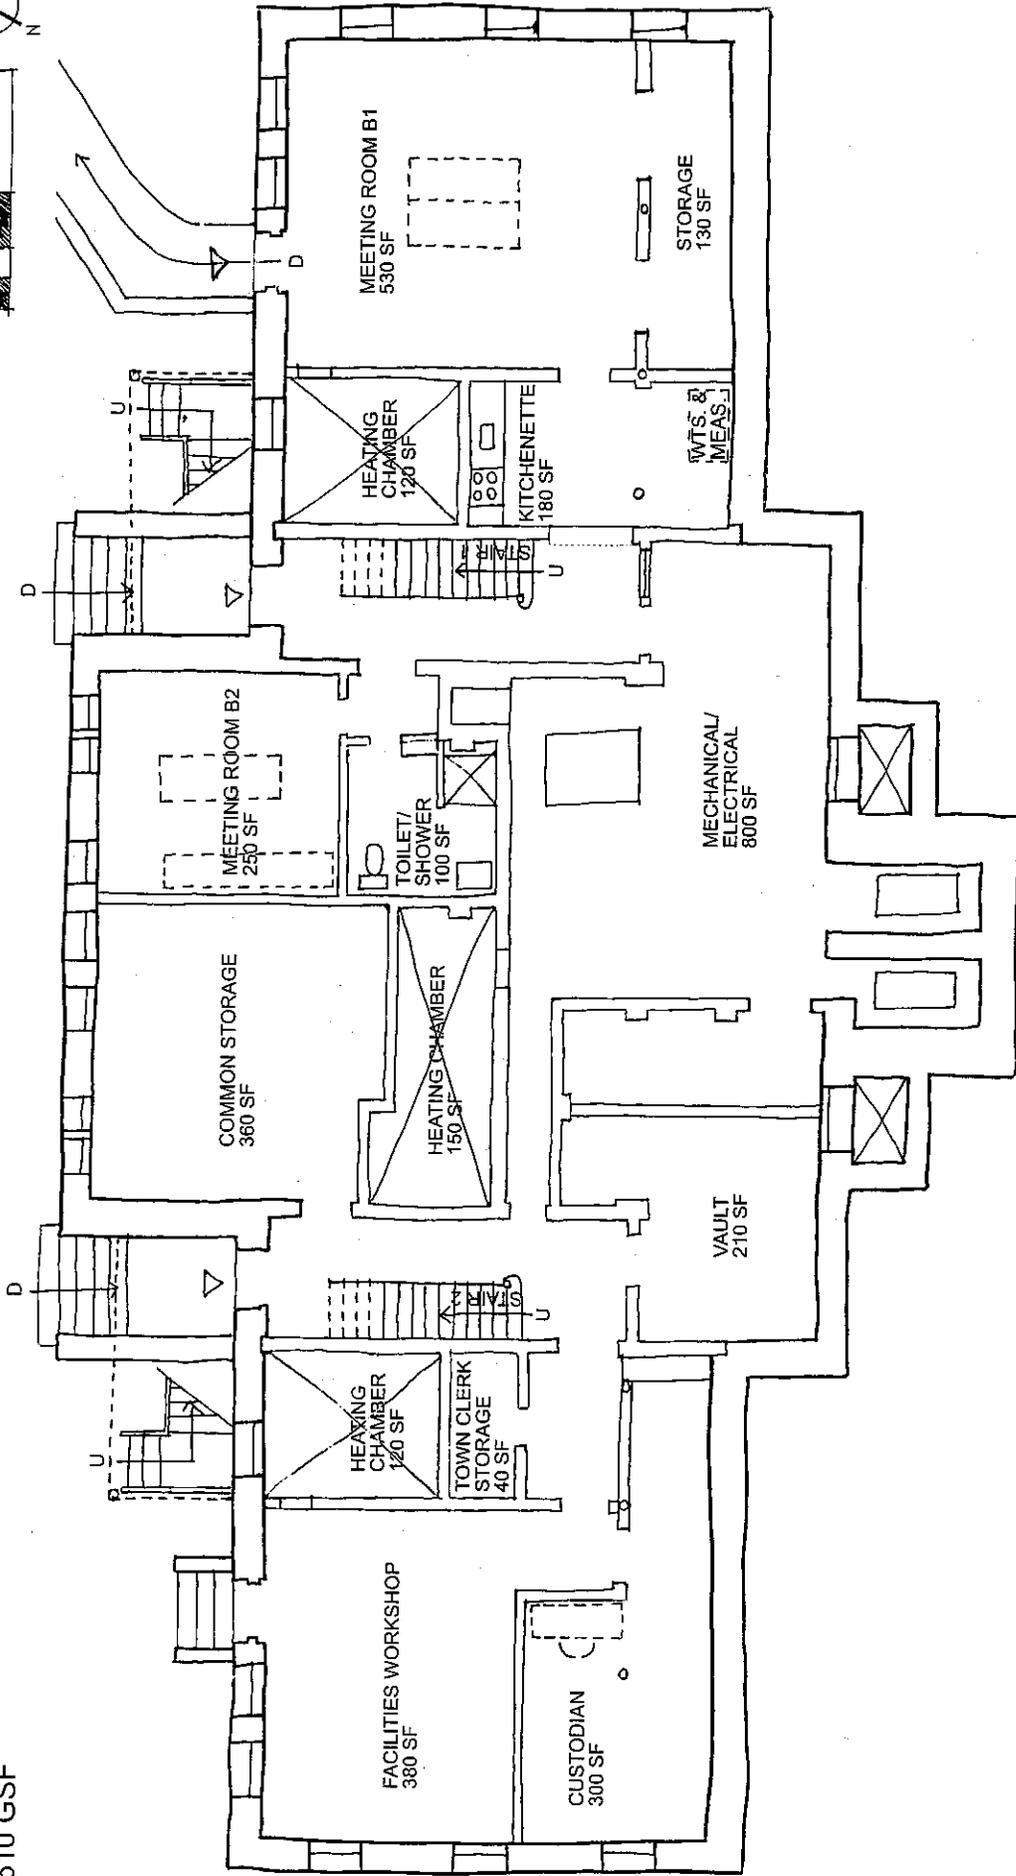
Lower Level Plan  
Existing Conditions  
5610 GSF

Town Offices, Site Plan Existing Conditions, October 22, 2007  
Town Offices, Lower Level Plan Existing Conditions, October 22, 2007  
Town Offices, First Floor Plan Existing Conditions, October 22, 2007  
Town Offices, Second Floor Plan Existing Conditions, October 22, 2007

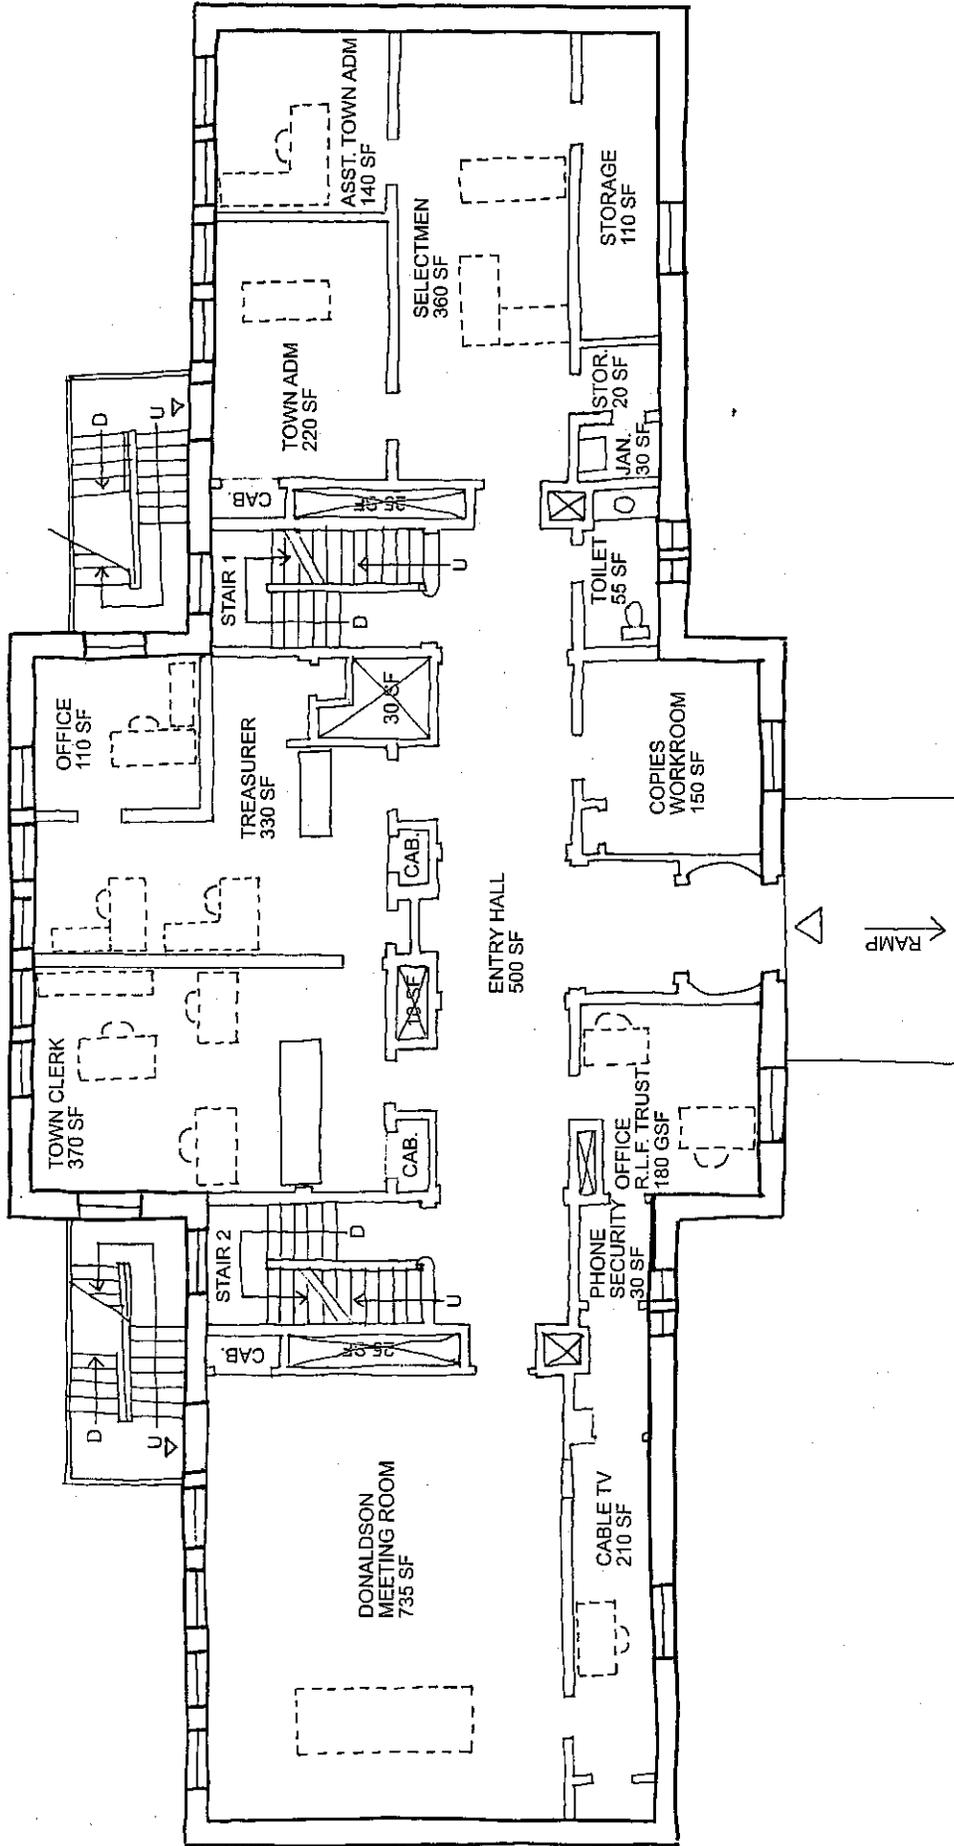
First Floor Plan  
Existing Conditions  
4880 GSF

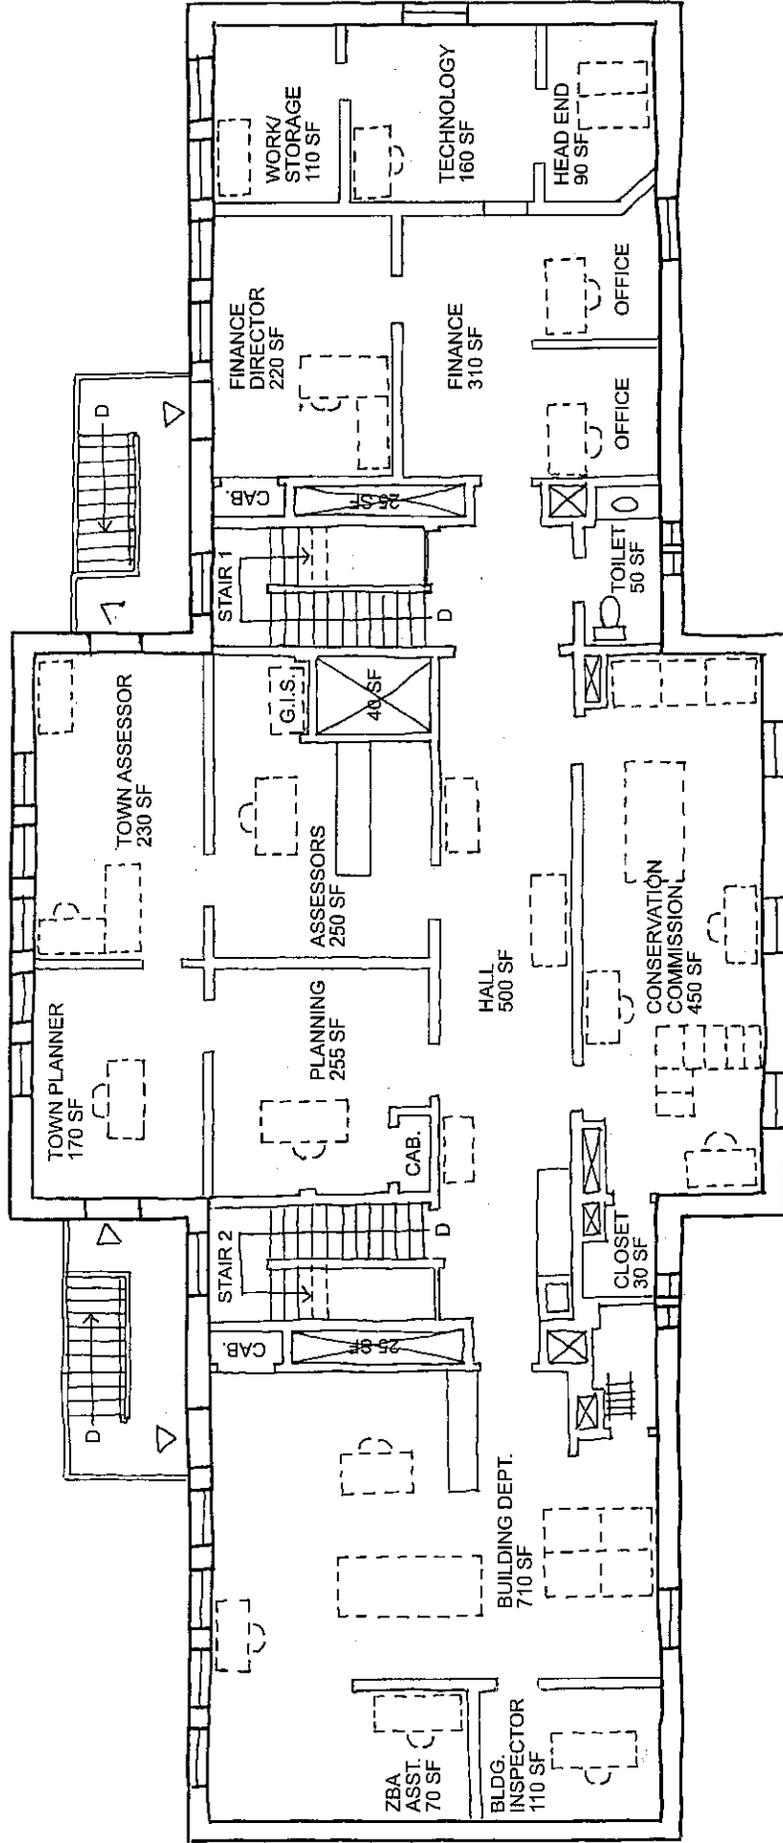
Second Floor Plan  
Existing Conditions  
4880 GSF
